Township of Uxbridge Public Library Board Meeting Agenda

Uxbridge Public Library – Building Condition Assessment

9 Toronto Street South, Uxbridge, Ontario

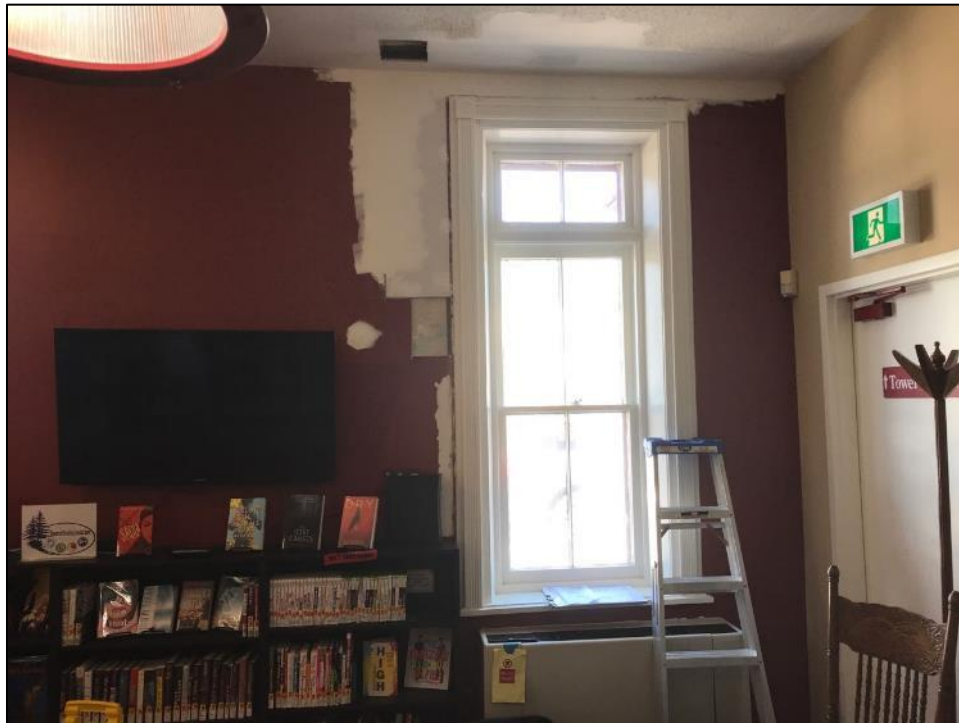
Water damage to plaster wall and ceiling finishes was observed in several locations. Damage was most prevalent near the exterior walls and above windows (refer to Photograph 2, Photograph 3, and Photograph 4). In some locations water damage coincided with locations where mechanical piping was un-insulated or insulation had become damaged. In one location (Photograph 4) a bucket was found about the t-bar ceiling collecting water from an un-insulated section of pipe.

Photograph 2 - Water staining - previous repair

1. Review and reinstate insulation on piping near exterior walls. Much of the interior damage related to water appeared to be at pipes that have lost insulation.
2. Remove auto-hold from door to stair on the lower level of the addition. This door is required to be closed while not in use.
3. Consider adding meshing to the existing steel stair guard to prevent it from being climbable.
4. Remove storage boxes from corridor of upper level of the original library. Floor loading should be limited to 2.4 kPa (50 psf) for this type of floor.
5. Ensure existing downspouts and gutters are functional and effectively diverting water away from the building.
6. Client identified vents in the exterior walls adjacent interior radiators. These vents are no longer needed and should be sealed and insulated to prevent further damage from freezing.

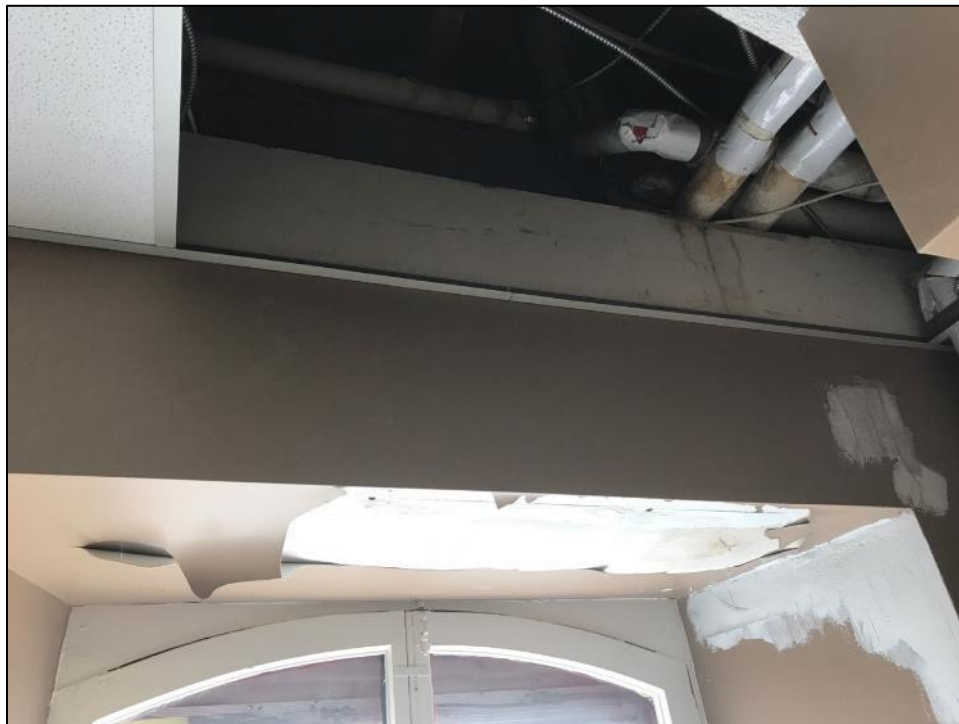
Photograph 3 - Water staining – damaged pipe insulation

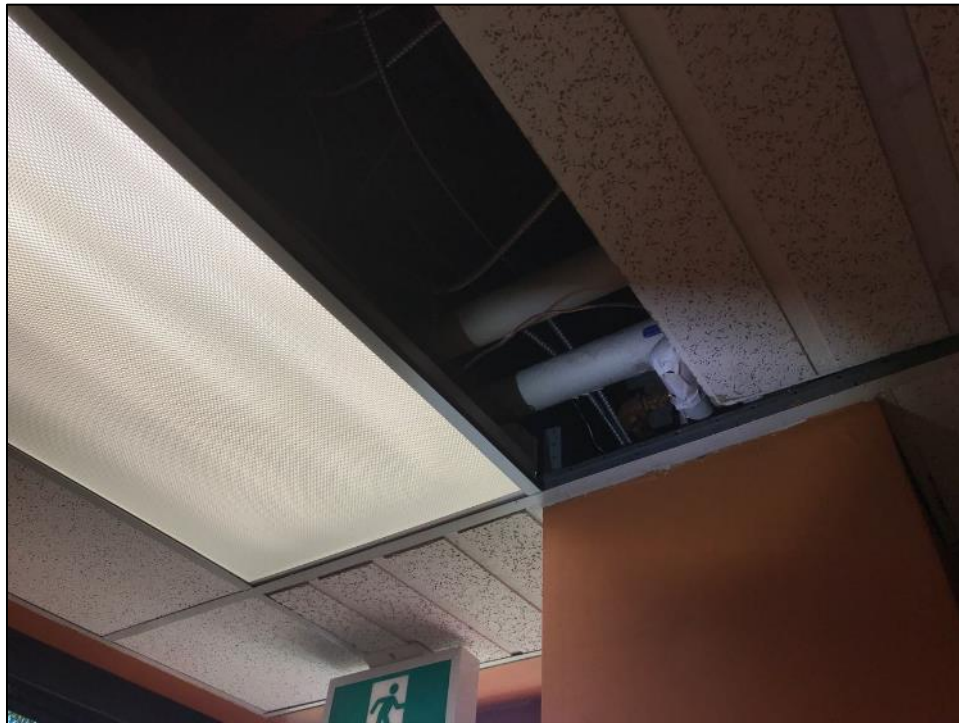
Photograph 4 - Ceiling water staining – bucket below pipes

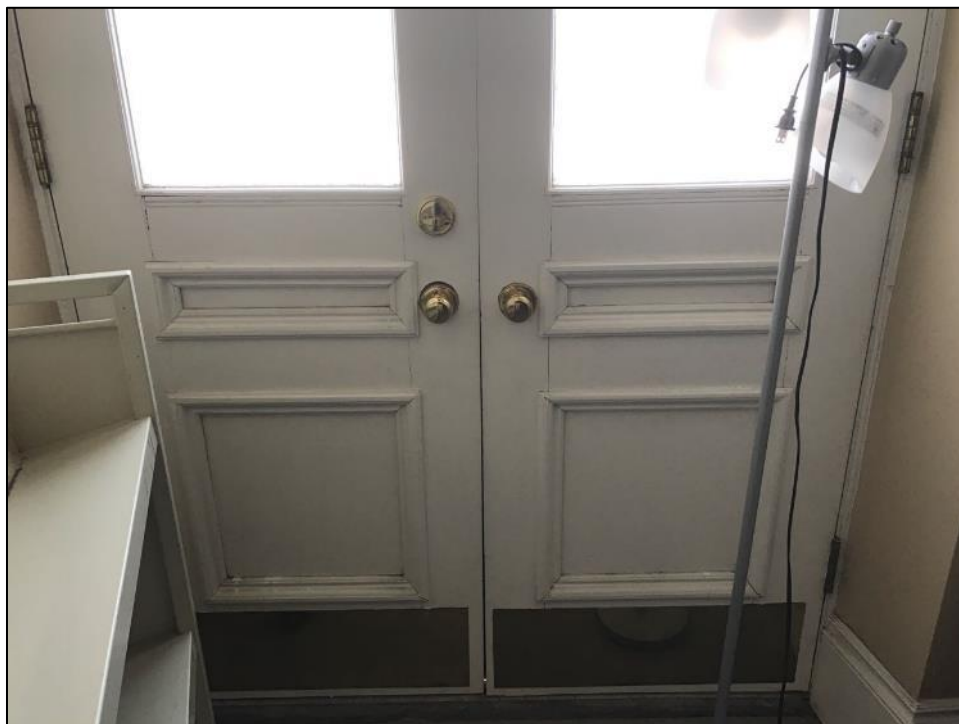
Photograph 5 – Blocked fire exit

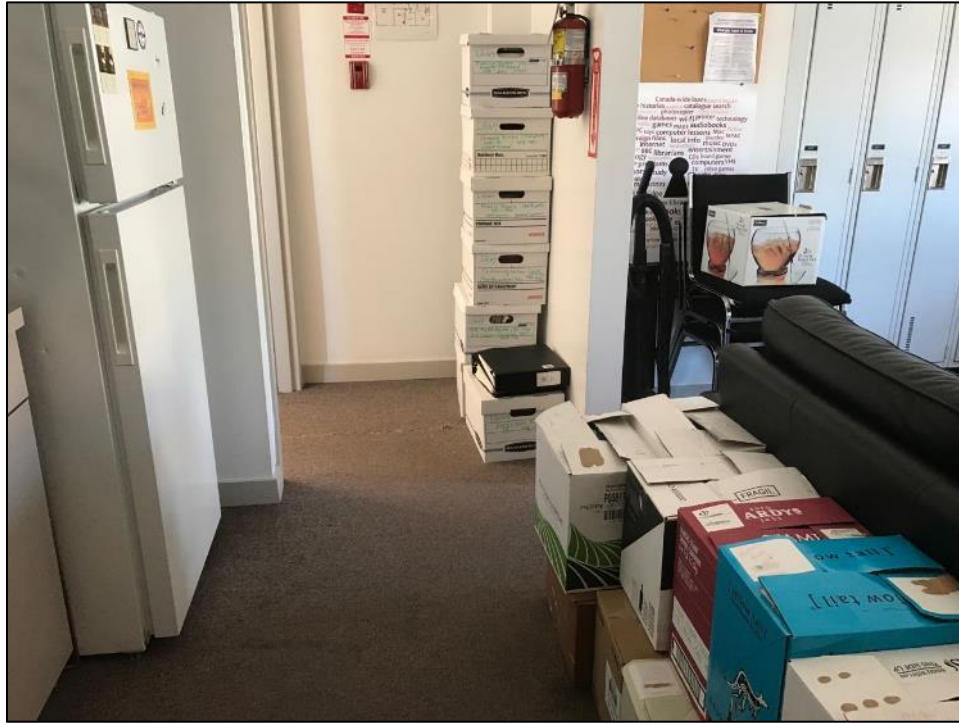
Photograph 6 – Corridor used for storage

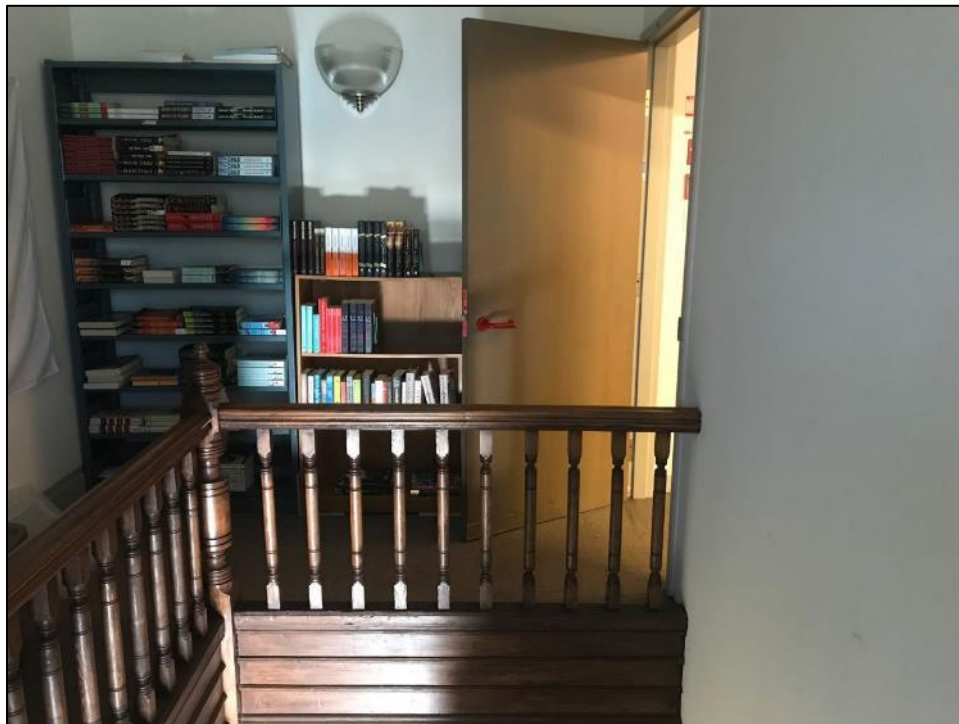
Photograph 7 – Book shelving and storage in exit path

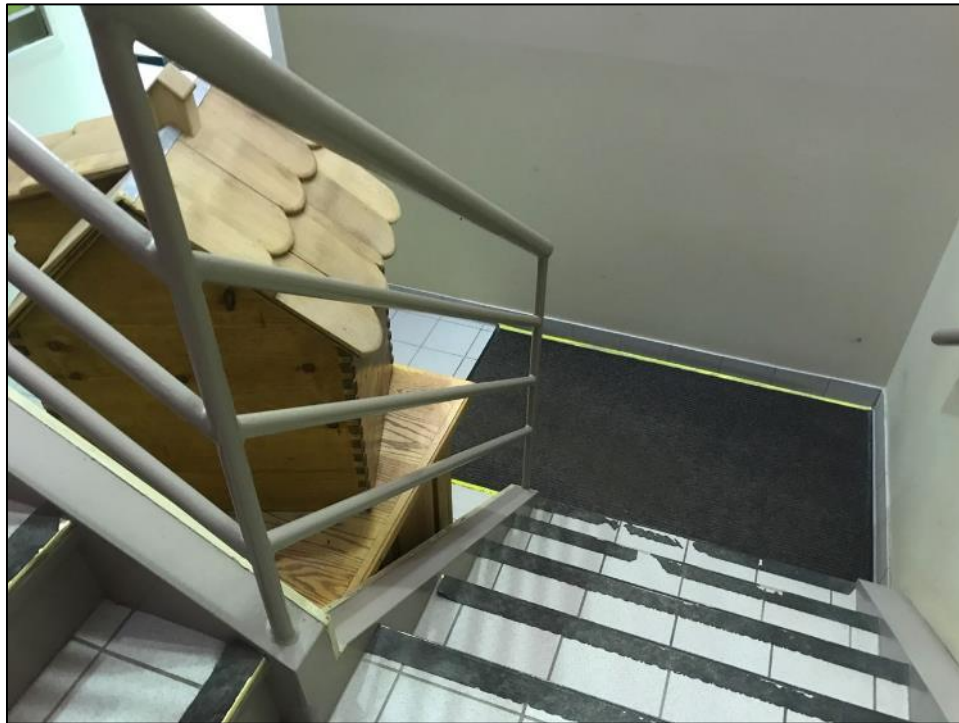
Steel guard for the stair connecting the two levels in the new addition was observed to be climbable (refer to Photograph 8). The door from the lower level to stair in the new addition was found to have an “auto-hold” preventing it from closing on its own (refer to Photograph 9).

Photograph 8 – Climbable Stair Guard

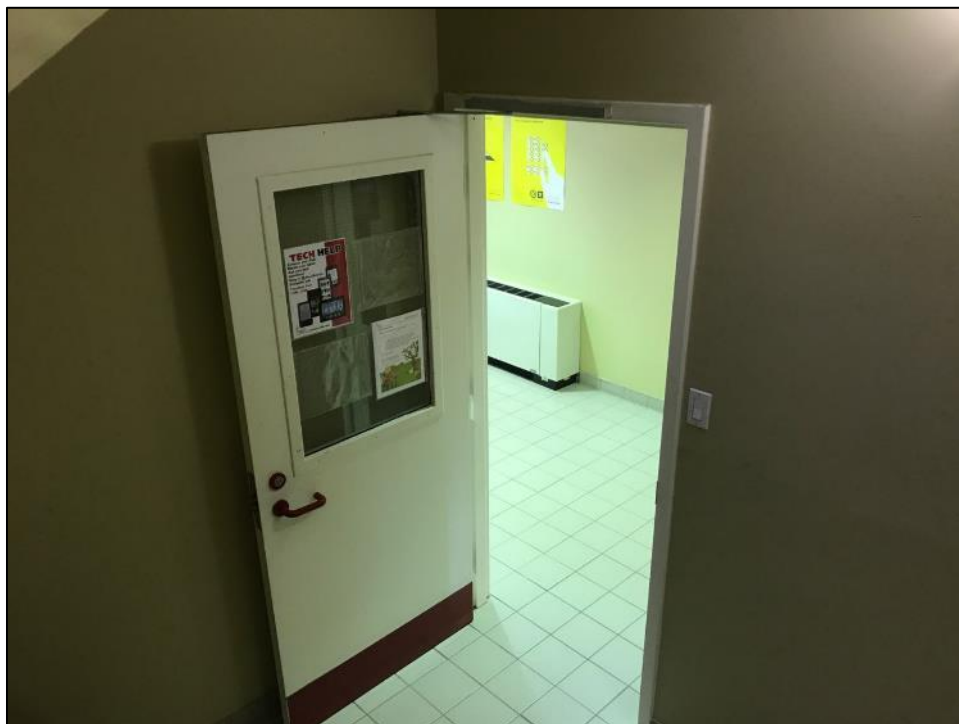
Photograph 9 – Auto-hold on door from stair to lower level

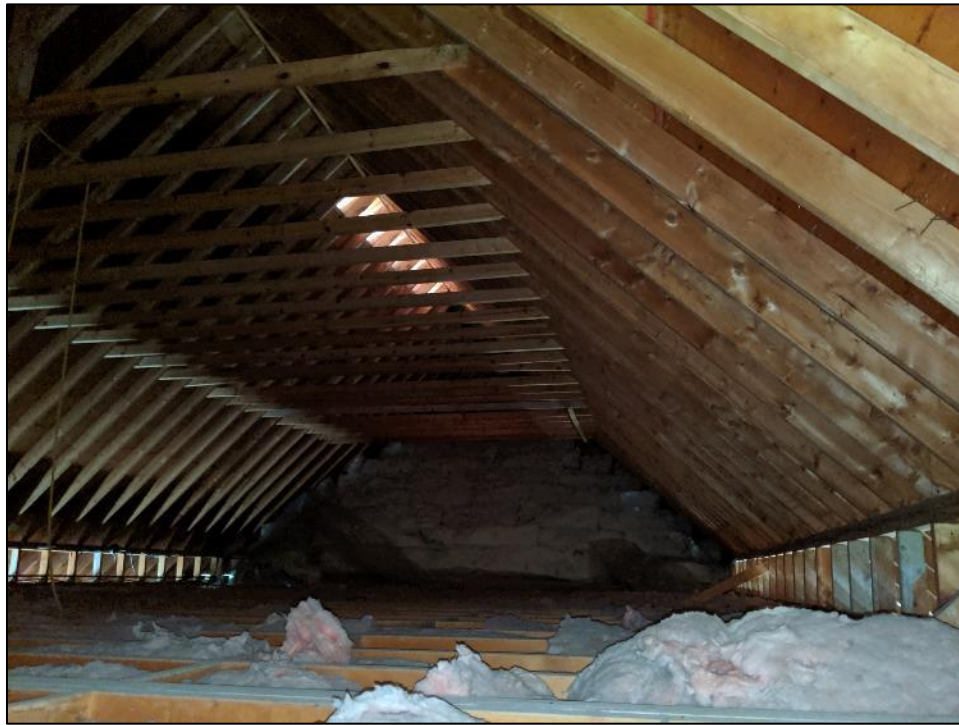
Wood-framed knee walls above the Library Stack Room were found to be unbraced on each side of the building (refer to Photograph 10).

Photograph 10 – Unbraced knee-walls above Library Stack Room

3. Add wood knee-wall bracing to the walls above the Library Stack Room.
4. Repair cracks in mortar joints in exterior brick and stone masonry walls. As previously stated, it is critical that the mortar used to repoint the joints is of similar strength and stiffness to the existing (lime-based). Use of a stiff repointing mortar (portland cement based) will result in further damage to the brick and stone masonry walls.

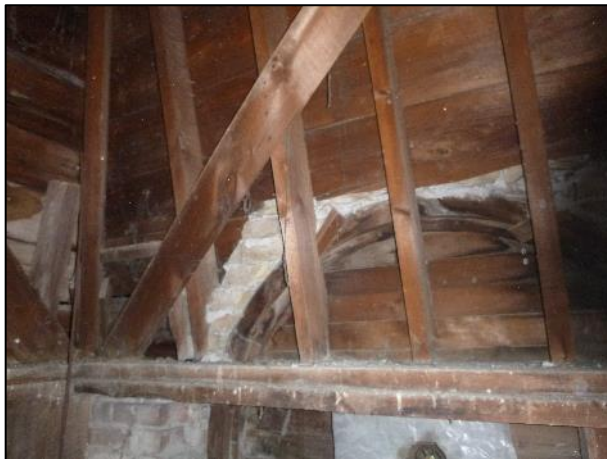
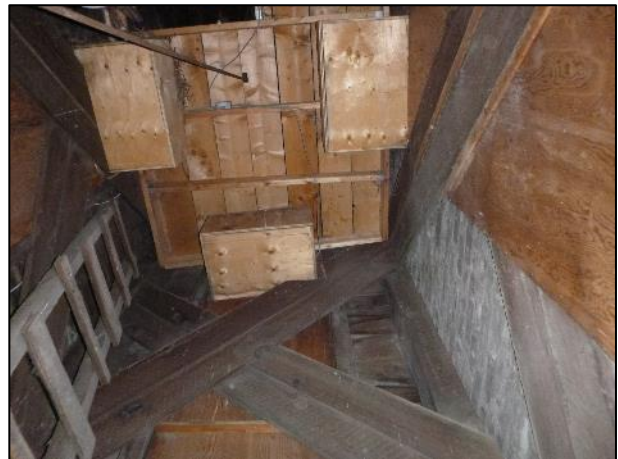
Localized damage to the wood framing in the Tower was observed (refer to Photographs 11a and 11b). Cross-bracing and connections were found to be missing in certain locations.

Photograph 11a, b: Wood framing in tower structure of original building

1. Repair damaged wood framing in tower structure, including:
 - a. Re-instate wood cross-bracing and stud wall connections.
 - b. It is recommended that steel ring beams are added at two locations (third-points) to provide additional stability to the tower structure.

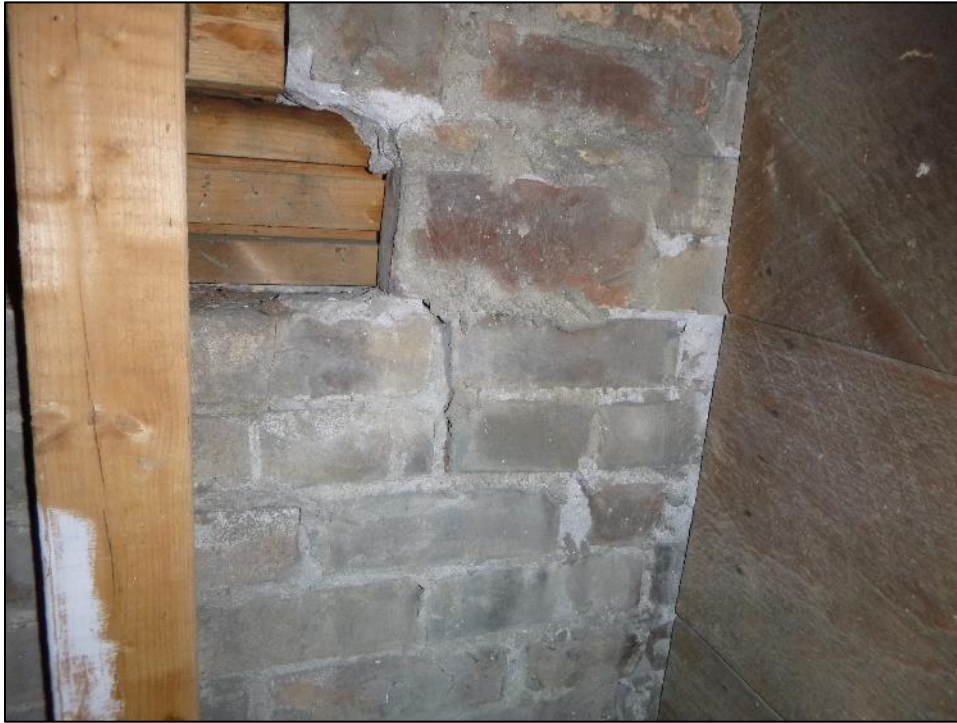
Localized damage to the brick mortar joints was observed in several locations within the Tower (refer to Photograph 12). Medium to wide cracking in the mortar joints was observed.

Photograph 12 – Wide masonry cracking in tower

2. Repair cracks in mortar joints in brick masonry tower walls. Localized steel rods may be required at locations where wide cracking was observed. It is critical that the mortar used to repoint the joints is of similar strength and stiffness to the existing (lime-based). Use of a stiff repointing mortar (portland cement based) will result in further damage to the brick and stone masonry walls.

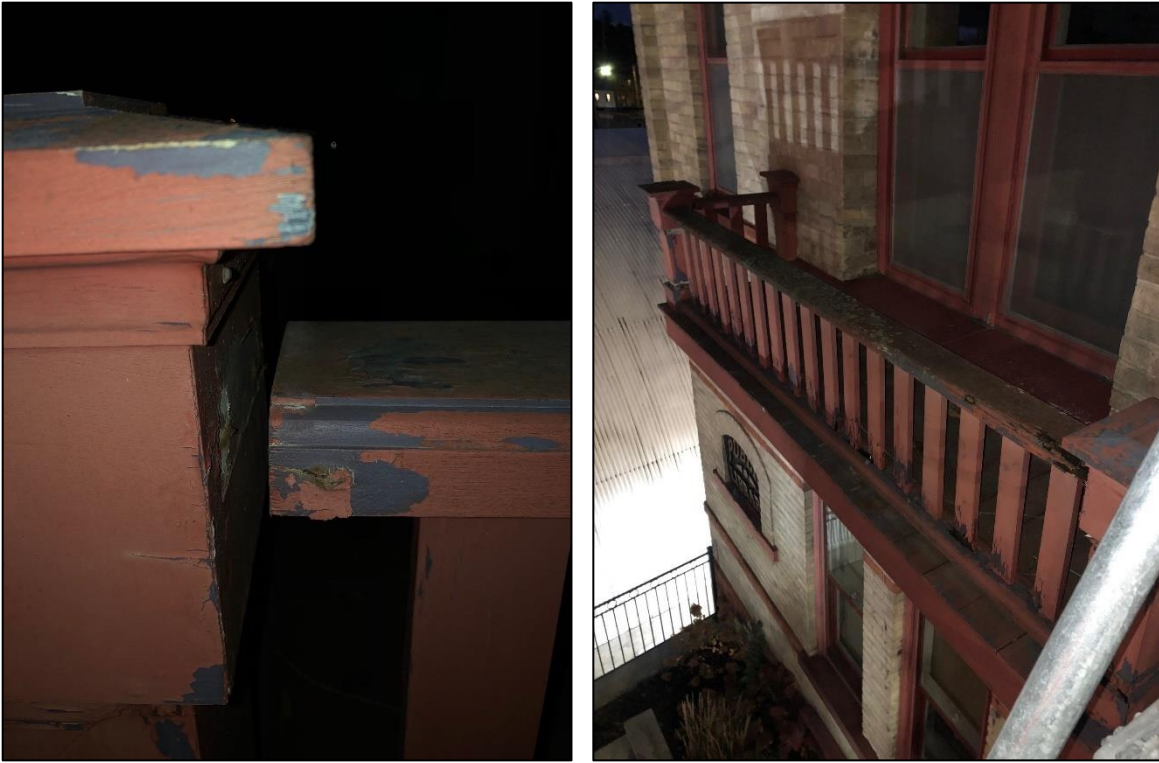
Our client has indicated that the timber porch on the north side of the original building was in poor condition and had observed severe rot locally (refer to Photographs 13a and b).

Photograph 13a, b: Wood framing condition of timber-framed balcony (client provided photos)

7. Locally repair damaged wood-framed porch and original wood-framed windows.

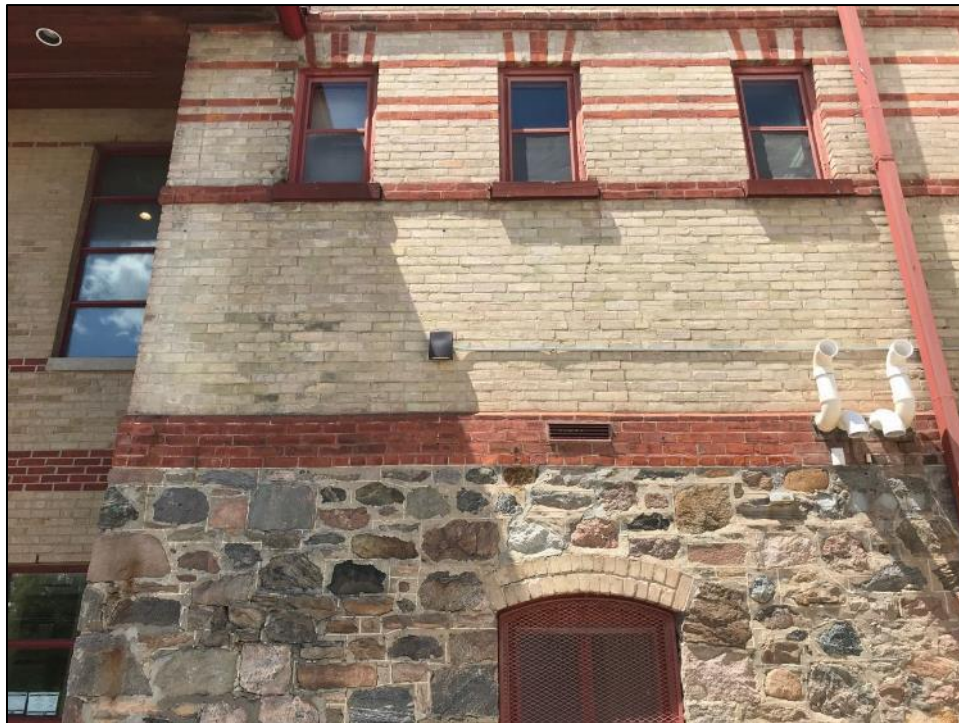
Localized damage to the brick, stone, and mortar joints was observed in several locations. Medium to wide cracking in the mortar joints was observed. Refer to Photograph 14 and 15.

Photograph 14 – Wide cracking in brick and stone at rear of building

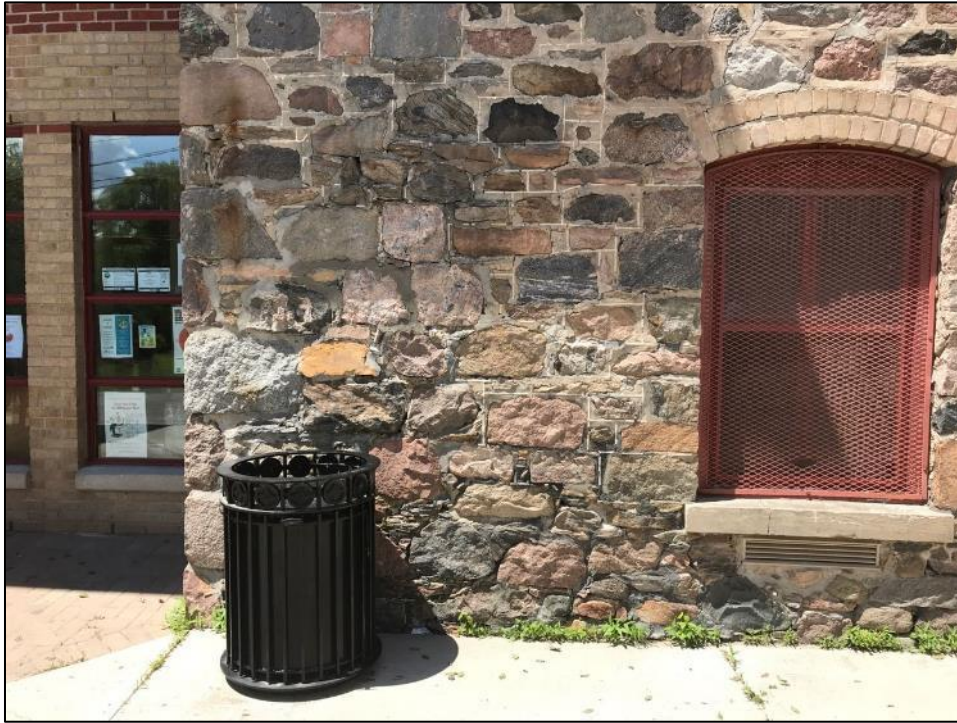
Photograph 15 – Stone masonry wall requiring repointing

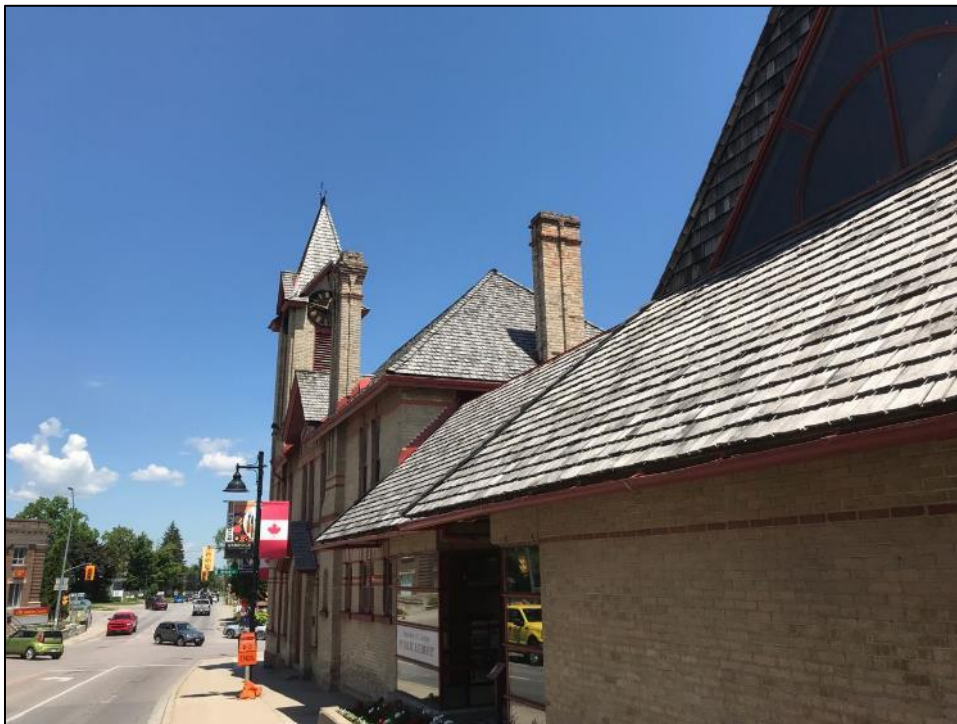
Brick chimney's that were capped were in fair condition; however, chimney's that were not capped were in poor condition (refer to Photograph 16).

Photograph 16 – Damaged brick chimney (without cap)

5. It is recommended that the damaged concrete block masonry is locally repaired and patched to prevent water infiltration at the damaged locations.
6. Locally repair damaged brick masonry and mortar joints at the chimney that has not been capped. Once repair work is complete, add cap with drip edge to prevent further damage.

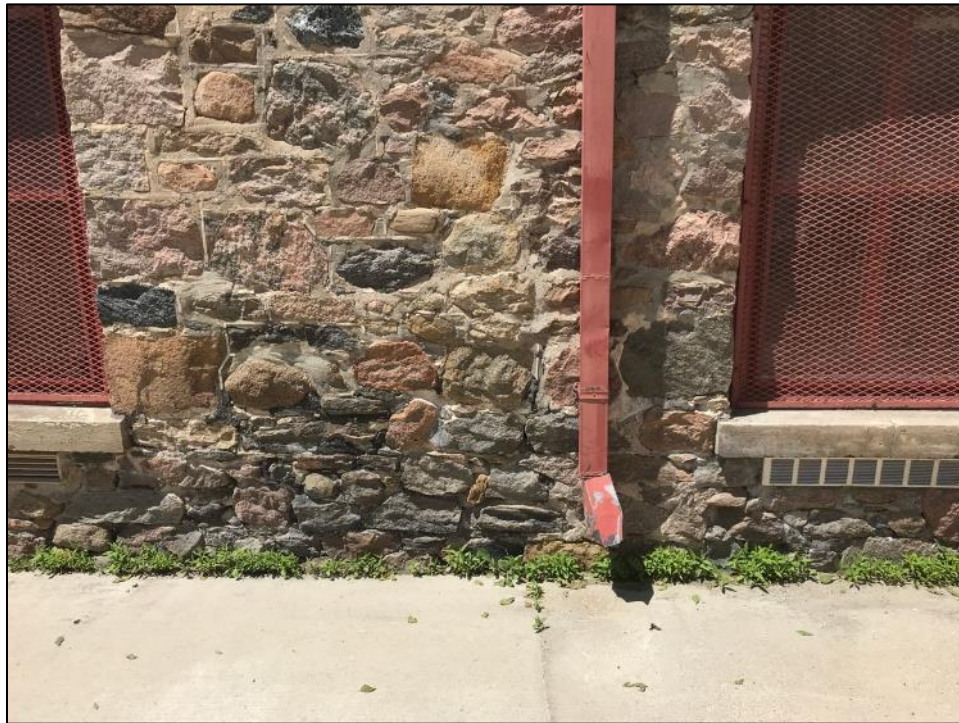
Water staining, and mild efflorescence was observed on the exterior of stone masonry walls at the location of the damaged downspout (refer to Photograph 17). These observations are indicative of water infiltration. It is not known whether water is actively entering the building.

Photograph 17 – Damaged downspout

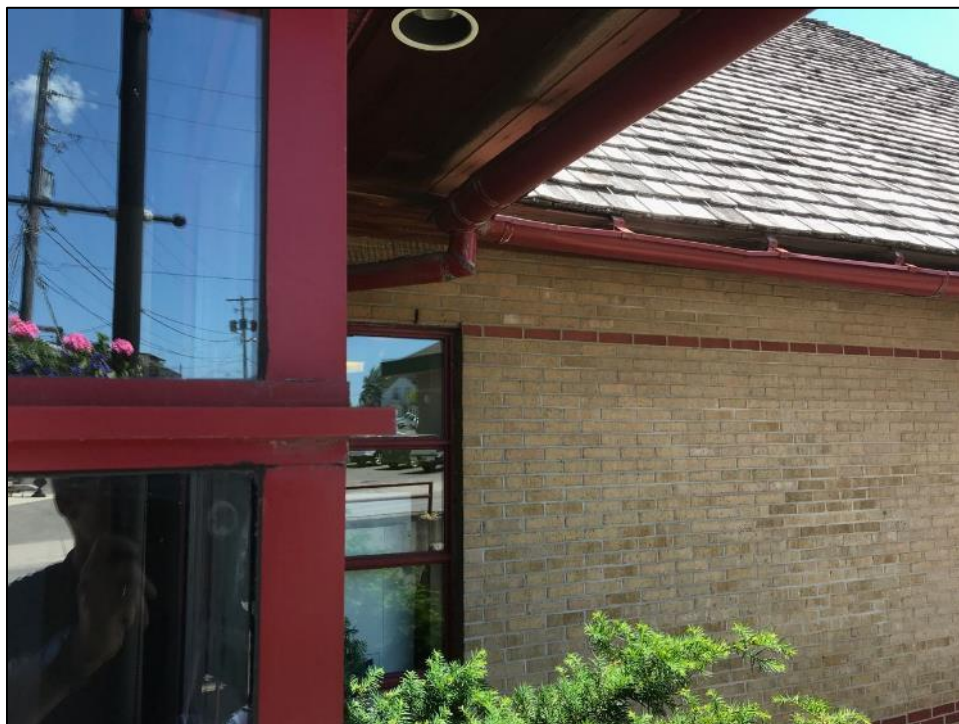
Damaged gutters were observed at the eaves of the newer addition to the building (refer to Photograph 18).

Photograph 18 – Damaged gutters

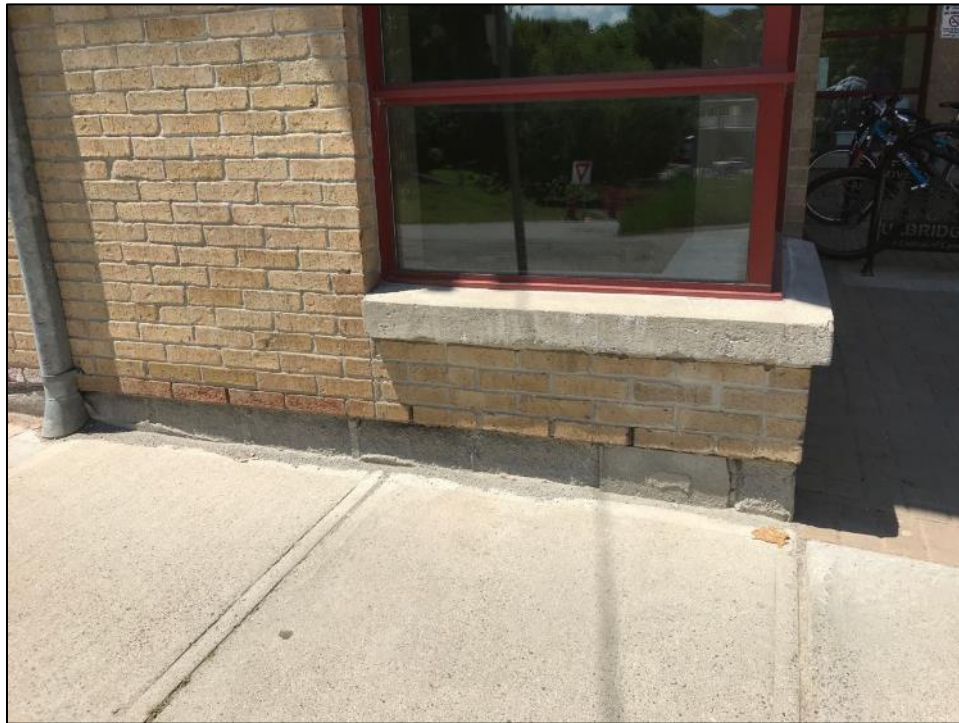
Medium to severe spalling was observed in the concrete block in the newer addition (refer to Photograph 19). Observed spalling was likely the result of freeze-thaw action. Water that infiltrates the wall can become trapped without a proper drainage path. This trapped water expands as it freezes. The observed spalling is likely the result of this expansion.

Photograph 19 – Concrete block foundation wall spalling
