Township of Uxbridge Public Library Board Meeting Agenda

Uxbridge Public Library – Building Condition Assessment

9 Toronto Street South, Uxbridge, Ontario

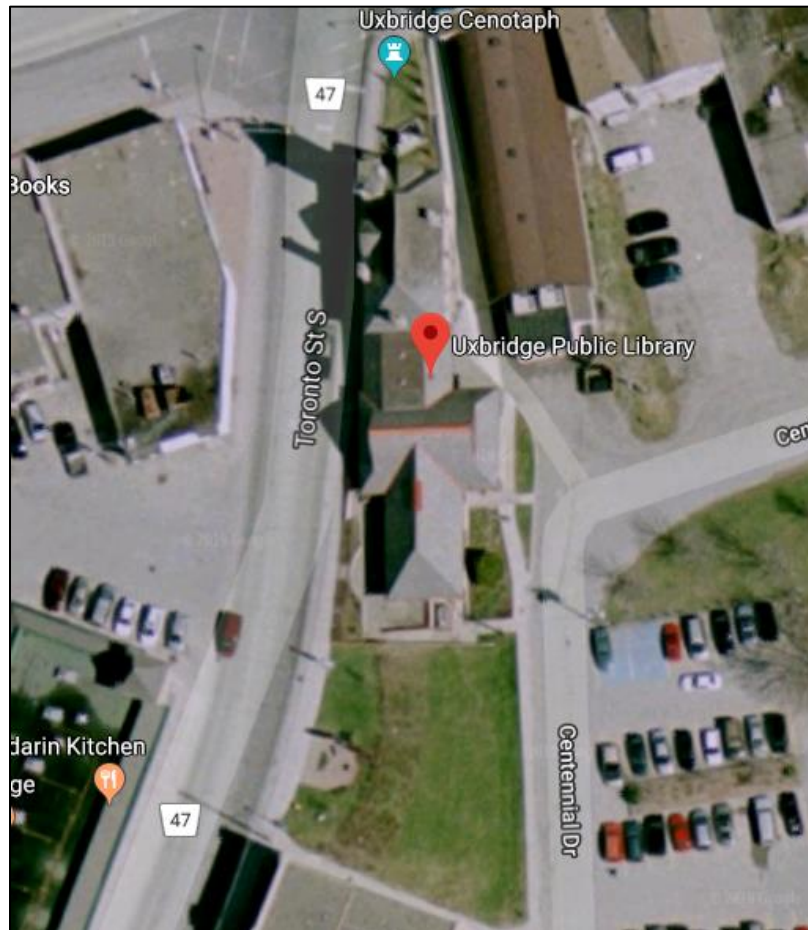
Photograph 1 - Aerial View of Building (Google Earth)

It was agreed on that the most appropriate location for a building addition would be the green space on the south side of the existing building. Refer to Photo 1 for an aerial view of the described location. It is the opinion of the consultant team that any new addition or expansion be sensitive to the original design of the building and does not disrupt the heritage value of the remaining building.
